# Manhole Inspection Summary

Manhole # S35EE\_041MH

Insp Date: **3/12/07 10:47 AM**

**Location** Address: **1220 SAINT PAUL ST**

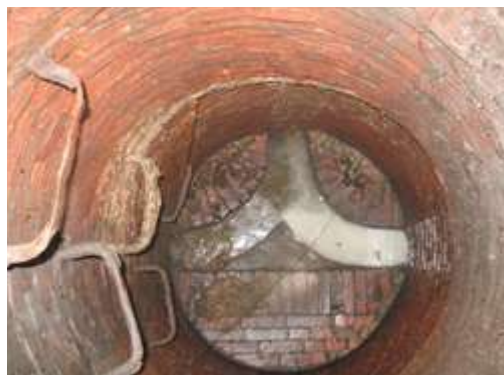
Top View

Corroded and missing steps. Evidence of surcharge - Bench debris. Channel debris.

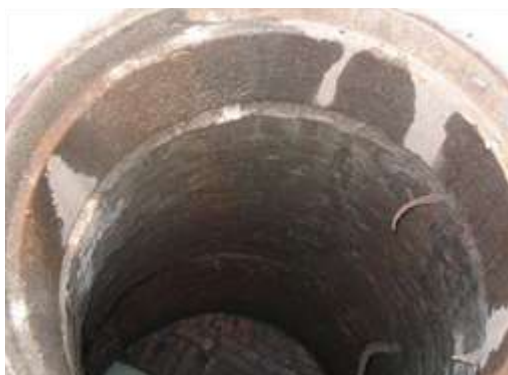
Defect

Frame leaks. Adjustment deterioration and infiltration. Corbel infiltration.

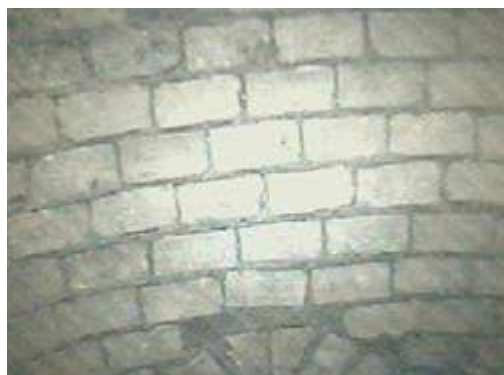
Defect

Barrel deterioration and infiltration.

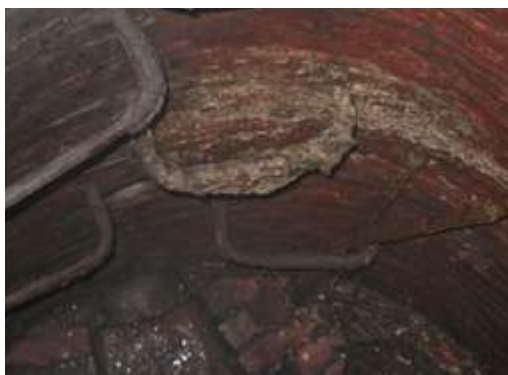
Defect

Evidence of surcharge. Corroded steps.

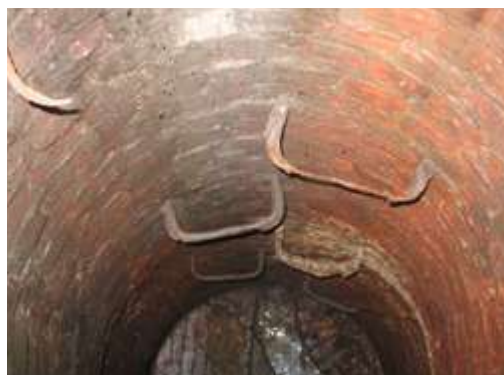
Defect

Corbel and Barrel infiltration.

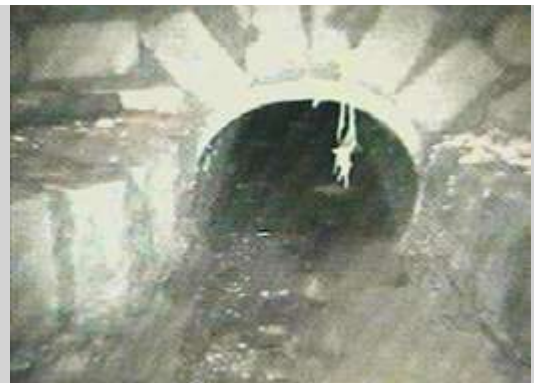
Pipe Out @ 12 O'Clock

Deposits: ☐ None ☒ **Mud** ☐ Sludge ☒ **Debris** ☒ **Grease**

Infiltration: **Evidence** Pipe Seal Cond: **Roots**

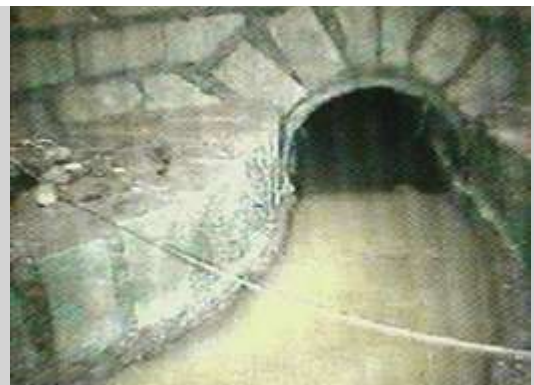
Pipe In @ 3 O'Clock

Deposits: ☐ None ☒ **Mud** ☐ Sludge ☒ **Debris** ☒ **Grease**

Infiltration: **Evidence** Pipe Seal Cond: **Roots**

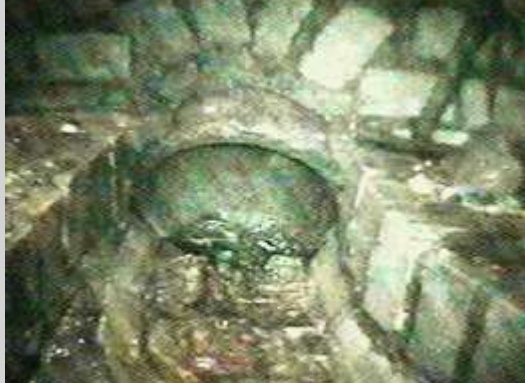
Pipe In @ 9 O'Clock

Channel deterioration.

Deposits: ☐ None ☒ **Mud** ☐ Sludge ☒ **Debris** ☒ **Grease**

Infiltration: **Evidence**
